# Lower South Platte River Master Plan

## Morgan County

## CDM Smith

April 9, 2018

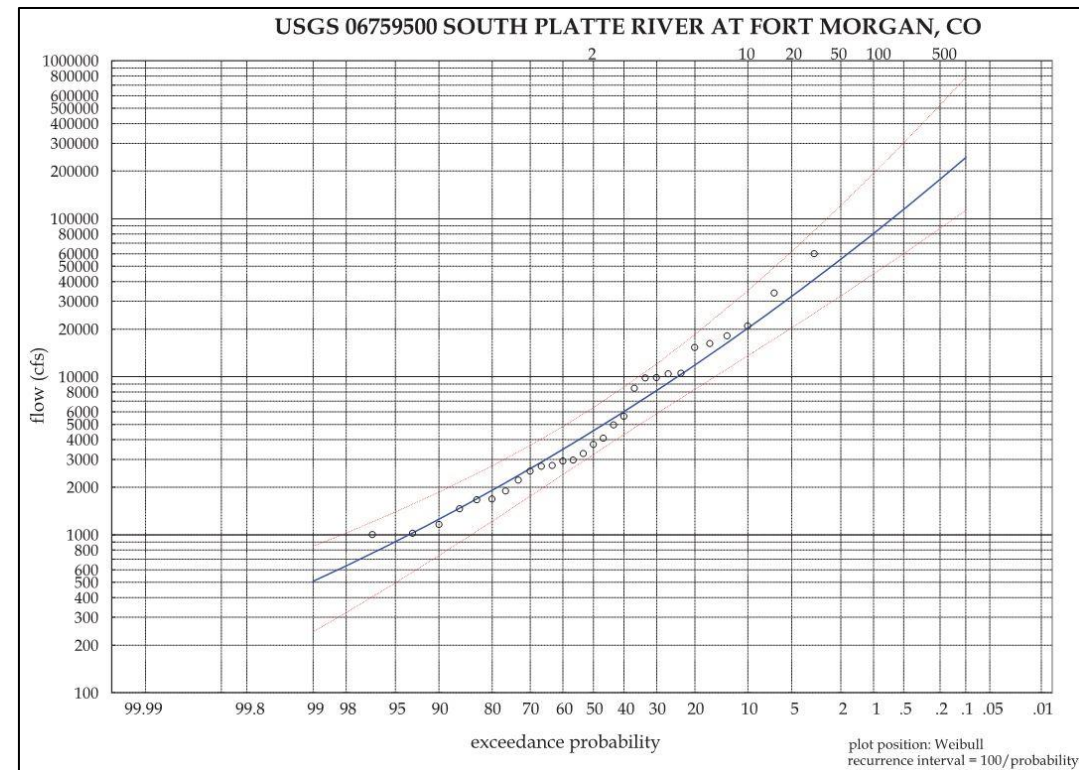
Figure 4-2: Fort Morgan, CO Exceedance Probability, including 2015 data (URS 2015)

The FFA utilized exceedance probability calculations at available gage sites along the lower South Platte River, including USGS 06758500 South Platte River near Weldona (Figure 4-1), USGS 06759500 South Platte River at Fort Morgan (Figure 4-2), USGS 06760000 South Platte River at Balzac (Figure 4-3), and USGS 06764000 South Platte River at Julesburg (Figure 4-4). The exceedance probability is the probability that a flood event of a given magnitude will occur in any given year. For example, a flood with an exceedance probability of 1% is typically referred to as the 100-year flood event, and has a 1% likelihood of occurring in any given year. Furthermore, a flood with an exceedance probability of 4% is referred to as the 25-year flood event and has a 4% likelihood of occurring in any given year. Based on guidelines established by the USGS (USGS 1982), the exceedance probability calculations incorporated into the FFA used the estimated 2013 discharge calculations, as well as discharge calculations from the 2015 flood, which occurred before the study ended, at each gage station to determine discharge for selected flood frequencies (Table 4-2).

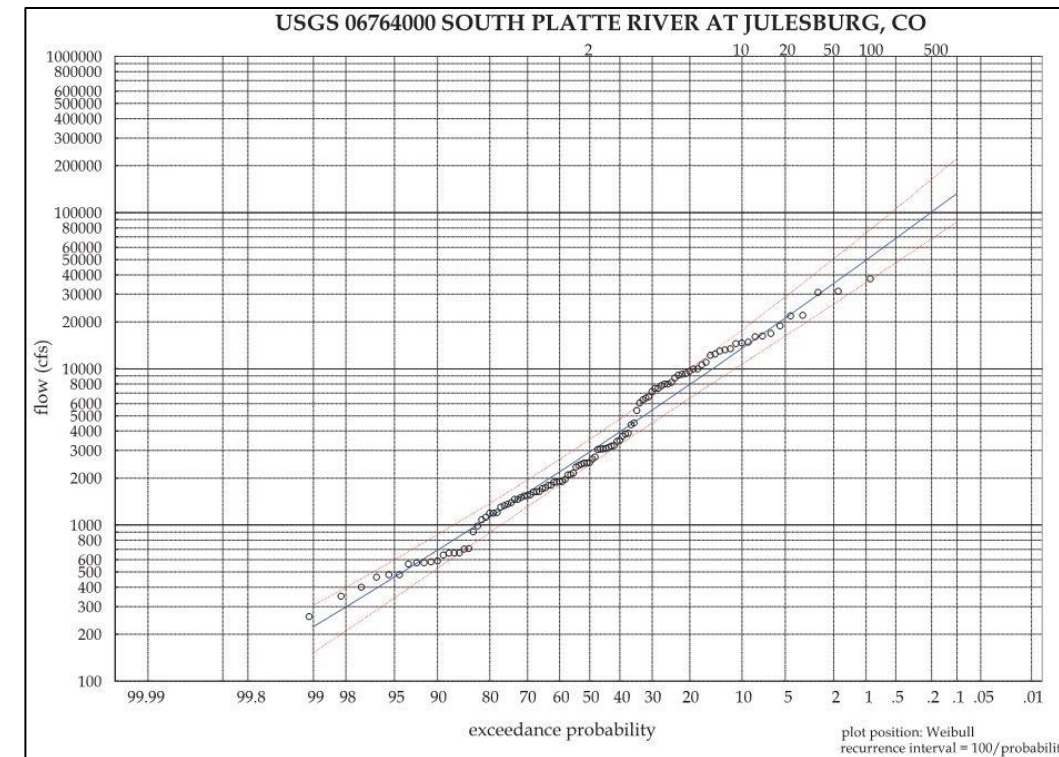
Figure 4-4: Julesburg, CO Exceedance Probability, including 2015 data (URS 2015)

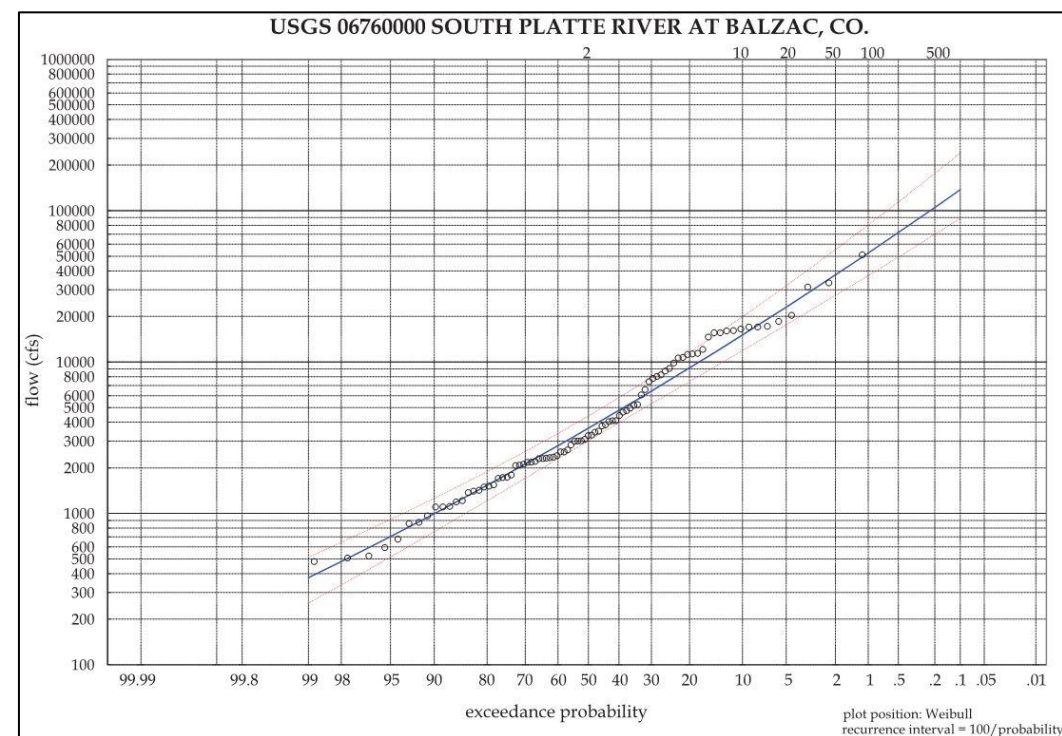
Figure 4-3: Balzac, CO Exceedance Probability, including 2015 data (URS 2015)

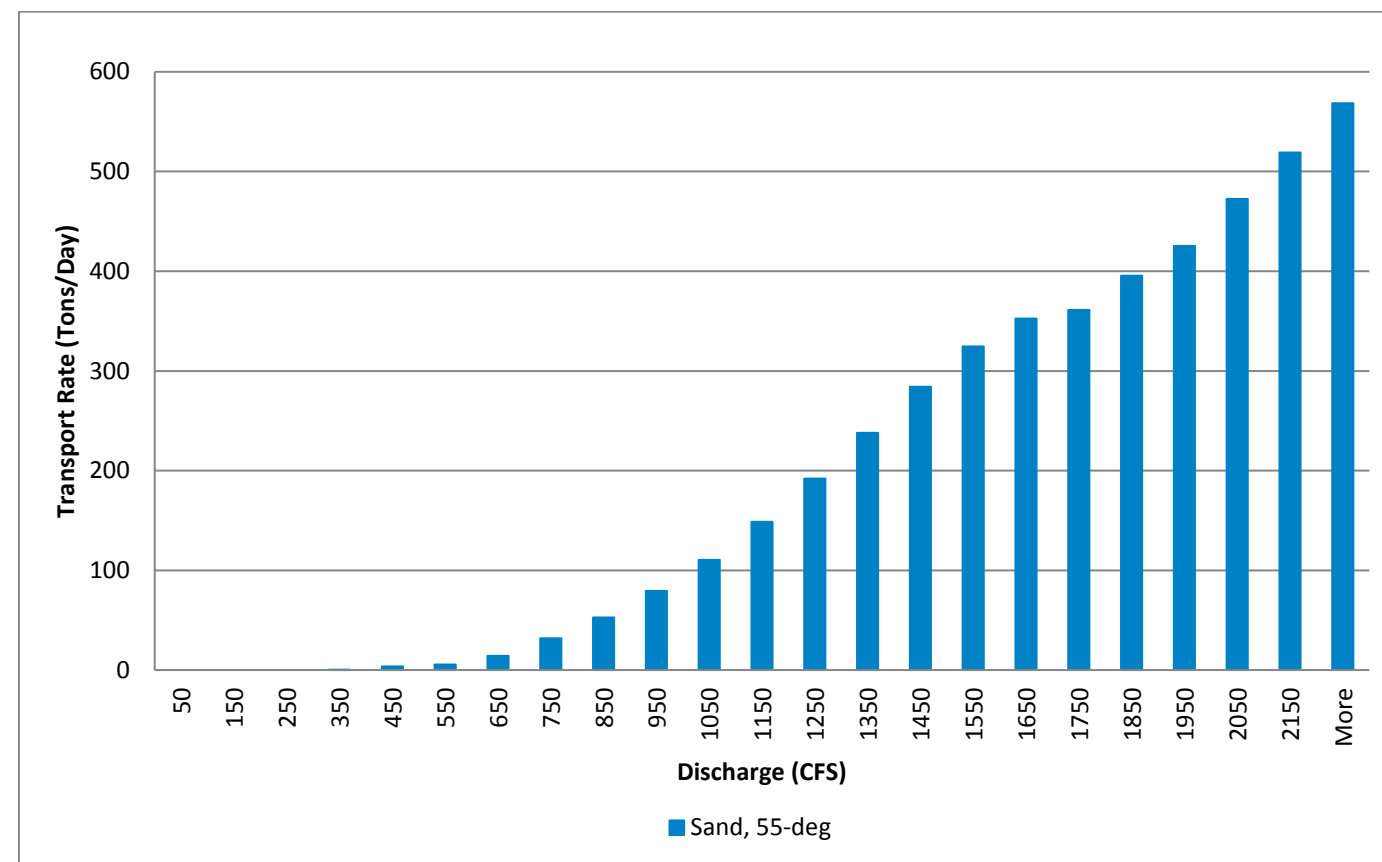
Figure 4-6: Sediment Transport Capacity in Fort Morgan at the Colorado State Highway 52 Bridge Crossing

The Sediment Transport Capacity module within HEC-RAS was used to calculate sediment transport rates across a range of flow events, allowing for the development of estimated sediment transport capacities at the cross-section upstream of State High 52 in Fort Morgan for different flow rates (Figure 4-6). The estimated transport rates using the Ackers-White equation were found to be consistent with USGS field measurements taken at multiple stream gage locations along the South Platte River near the project area.

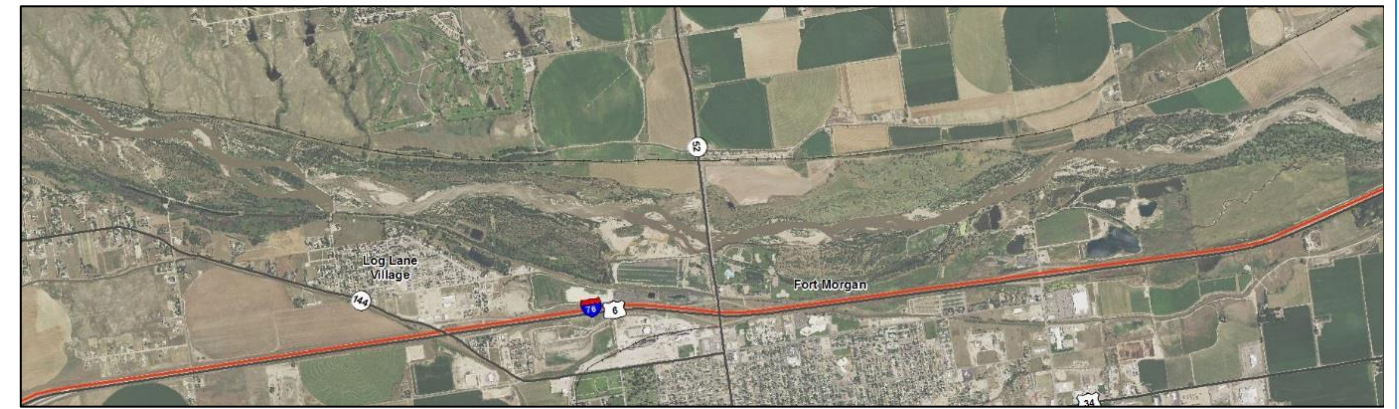
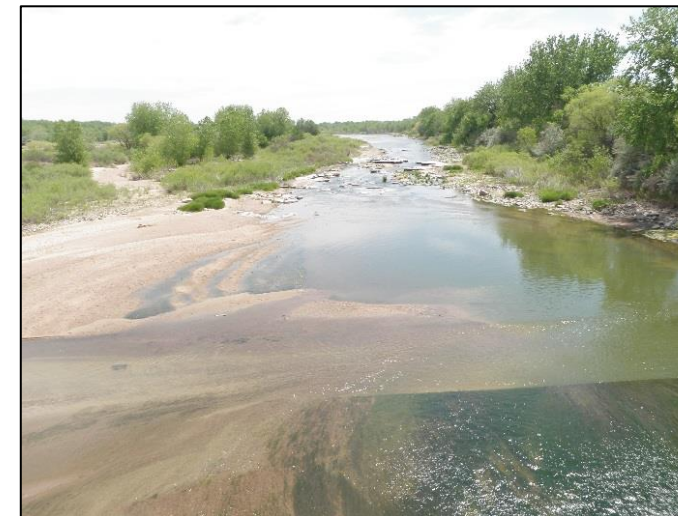
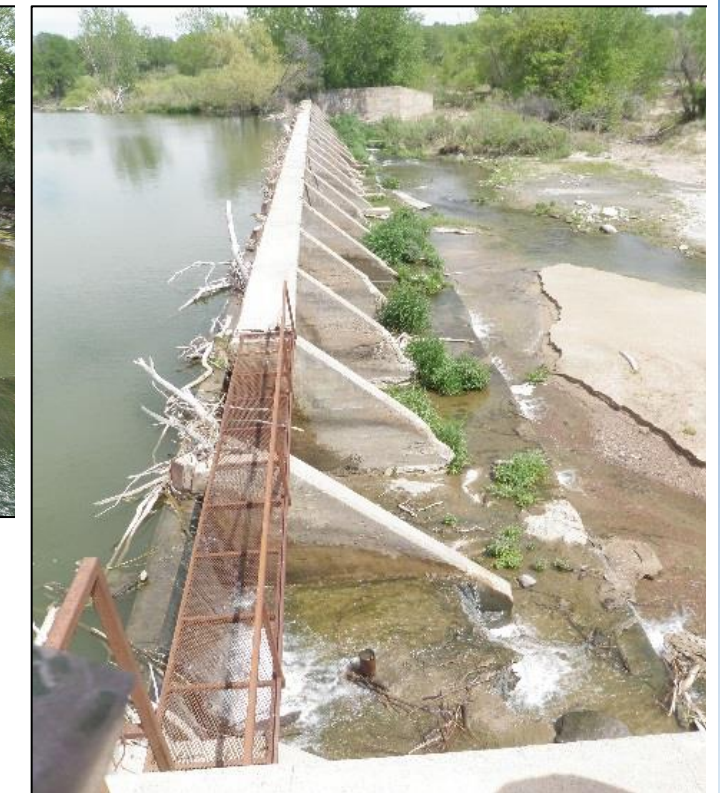
**Table 5-12: Reach 4 Summary**

RIVER CHARACTERISTICS			
Valley Setting	The river runs through a valley that is confined by urban channelization with minimal floodplain and riparian corridor.		
Channel Characteristics	The channel has low sinuosity and high stream power, with a broad left-hand bend. The channel is single thread, with multi-threads at low/medium flows, and forced narrowing by urbanization.		
RIVER STATISTICS			
Average Stream Power 10-year (lbs/ft <sup>2</sup> s)	1.27	Structures in the Active Channel	0
Average Stream Power 100-year (lbs/ft <sup>2</sup> s)	2.07	Structures in the Erosional Hazard Area	7
Number of Diversions Passing Sediment	0	Structures in the Historical River Channel	7
Number of Diversions Not Passing Sediment	2	Potential Erosion Points	6
Critical Infrastructure in the Active Channel	0	NPDES in the Active Channel	0
Critical Infrastructure in the Erosional Hazard Area	0	NPDES in the Erosional Hazard Area	2

Critical Infrastructure in the Historical River Channel	0	NPDES in the Historical River Channel	2
RISK ASSESSMENT RESULTS			
Flood Risk	<b>Risk: 3</b> <b>Risk Potential Score: 1</b> <b>Risk Severity Score: 3</b>	Reach saw significant flood impacts during the 2013 flood event, with some key infrastructure located within the floodplain.	
Fluvial Geomorphic Risk	<b>Risk: 6</b> <b>Risk Potential Score: 3</b> <b>Risk Severity Score: 3</b>	Straight, low sinuosity, and channelized by urban development with high stream power. High lateral migration and erosion potential with channel encroaching on the historical river corridor, agricultural land to the North, and significant assets in Fort Morgan to the South.	
Ecological Risk	<b>Potential for Restoration: 4</b> <b>Risk Score: 2</b> <b>Restoration Priority Score: 2</b>	<b>SVAP2 Average Score: 4.2.</b> Physical structures are present that restrict the movement of aquatic species, and there are large gaps in riparian vegetation. Algal growth is present, and there are very few aquatic habitat types.

Overall Risk Score	<b>14 - High</b>		
Restoration Recommendations	Mitigate factors that contribute to flooding by establishing an overflow channel and redirecting flow (see Section 7.2.1).

- **Reach 4:** This reach runs through the City of Fort Morgan, which saw significant flood impacts during the 2013 flood. Much of Fort Morgan sits above the floodplain, but some key infrastructure and assets were adversely impacted by the 2013 flood. The primary impacts included the overtopping and closure of Colorado State Highway 52, the breach of the berm adjacent to Riverside Park and subsequent flooding, the flooding at the Barlow Road interchange, and damage to the Upper-Platte Beaver diversion. In general, this reach can be considered geomorphically unstable due to the laterally constrained floodplain and to the geomorphic barriers present along this reach that serve to disrupt conveyance of sediment downstream. Ecological and environmental hazards are also present within the 100-year floodplain and could potentially be at risk during future flood events, including a water and sewer facility and a capped landfill.

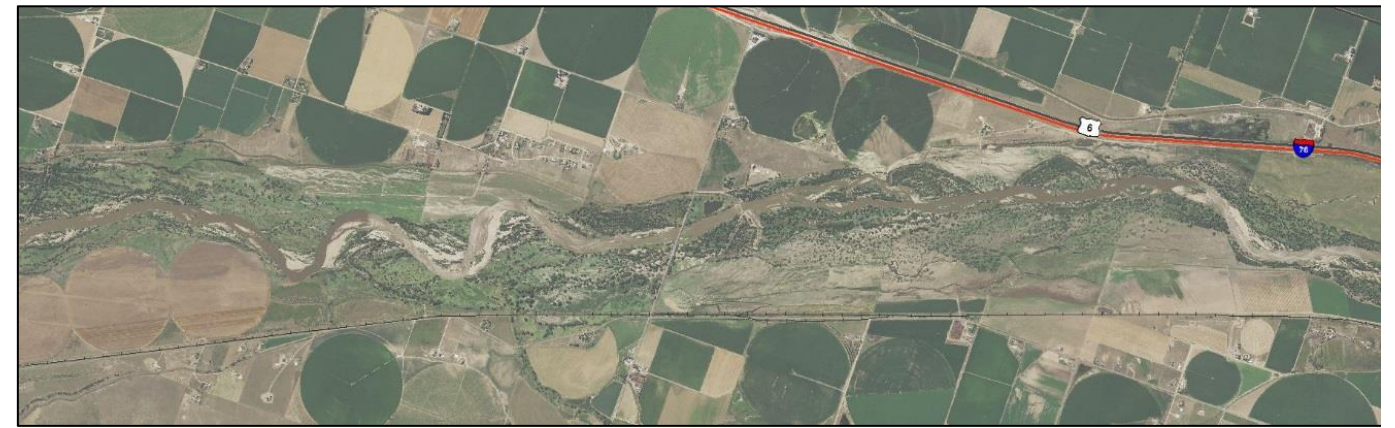
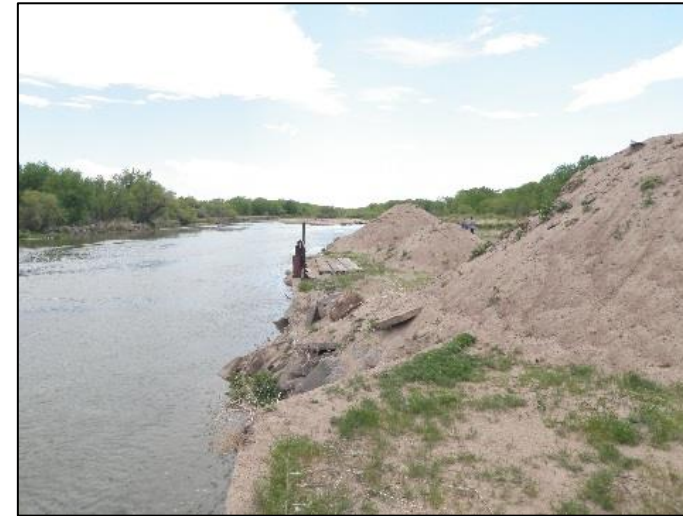
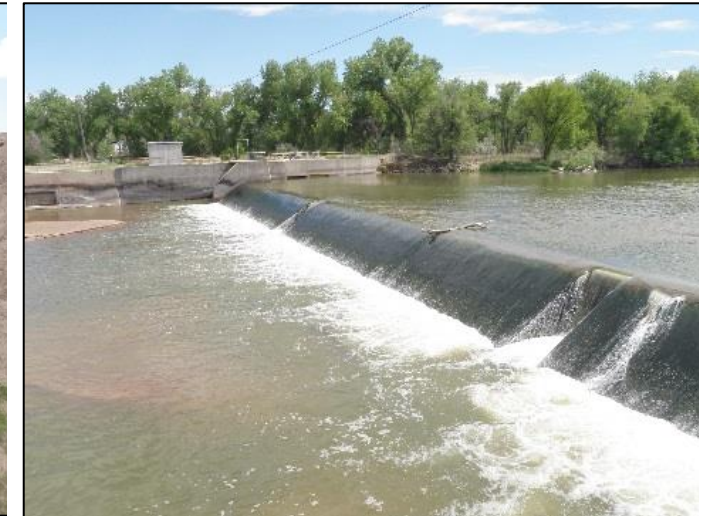
**Table 5-13: Reach 5 Summary**

RIVER CHARACTERISTICS			
Valley Setting	The channel runs through a partially confined valley with a partially connected floodplain and riparian corridor.		
Channel Characteristics	The channel is predominantly straight, single thread, with multi-threads and sandbars at low/medium flows, and one region with four high-frequency, low-amplitude meander bends (within the SWA). There is variable floodplain and riparian corridor connectivity, where connectivity is increased within the SWA and decreased adjacent to farm land.		
RIVER STATISTICS			
Average Stream Power 10-year (lbs/ft <sup>2</sup> s)	0.57	Structures in the Active Channel	0
Average Stream Power 100-year (lbs/ft <sup>2</sup> s)	1.14	Structures in the Erosional Hazard Area	5
Number of Diversions Passing Sediment	1	Structures in the Historical River Channel	5
Number of Diversions Not Passing Sediment	1	Potential Erosion Points	3
Critical Infrastructure in the Active Channel	0	NPDES in the Active Channel	0

Critical Infrastructure in the Erosional Hazard Area	0	NPDES in the Erosional Hazard Area	0
Critical Infrastructure in the Historical River Channel	0	NPDES in the Historical River Channel	0
RISK ASSESSMENT RESULTS			
Flood Risk	<b>Risk: 2</b> <b>Risk Potential Score: 1</b> <b>Risk Severity Score: 1</b>	Minimal infrastructure and assets within and adjacent to the active floodplain.	
Fluvial Geomorphic Risk	<b>Risk: 4</b> <b>Risk Potential Score: 2</b> <b>Risk Severity Score: 2</b>	Medium to low sinuosity with medium stream power. Moderate lateral migration and erosion potential with channel encroaching on agricultural land, ~ 5 assets within the erosional hazard area, or on riparian corridor (within the SWA). Additional assets located adjacent to the historical river corridor.	
Ecological Risk	<b>Potential for Restoration: 5</b> <b>Risk Score: 2</b> <b>Restoration Priority Score: 3</b>	<b>SVAP2 Average Score: 5.0.</b> Physical structures are present that restrict the movement of aquatic species. Invasive species are present in the riparian zone, but there are relatively few vegetation gaps. Canopy cover over the stream channel is moderate.

Overall Risk Score	<b>11 - Medium</b>		
Restoration Recommendations	No specific projects were identified within this reach.

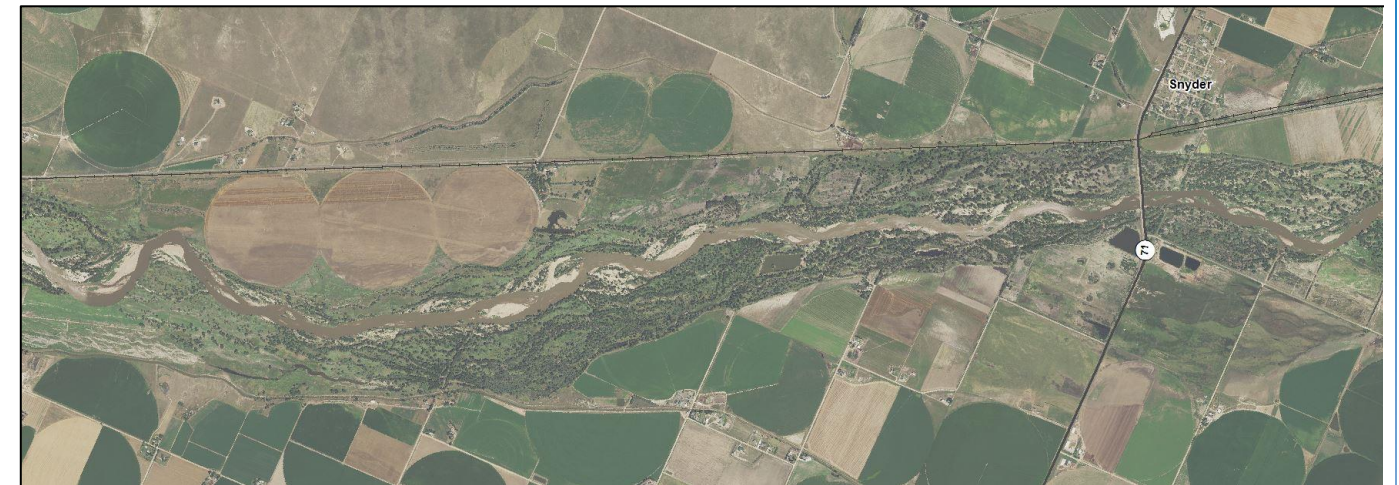
**Table 5-14: Reach 6 Summary**

RIVER CHARACTERISTICS			
Valley Setting	The channel sits in a partially confined valley with a connected floodplain and riparian corridor.		
Channel Characteristics	The river is a straight, very low-sinuosity, single-thread channel, with multi-threads and sandbars at low/medium flows. The channel has both floodplain and riparian corridor connectivity.		
RIVER STATISTICS			
Average Stream Power 10-year (lbs/ft <sup>2</sup> s)	0.47	Structures in the Active Channel	0
Average Stream Power 100-year (lbs/ft <sup>2</sup> s)	0.85	Structures in the Erosional Hazard Area	4
Number of Diversions Passing Sediment	0	Structures in the Historical River Channel	11
Number of Diversions Not Passing Sediment	1	Potential Erosion Points	0
Critical Infrastructure in the Active Channel	0	NPDES in the Active Channel	0
Critical Infrastructure in the Erosional Hazard Area	0	NPDES in the Erosional Hazard Area	0
Critical Infrastructure in the Historical River Channel	0	NPDES in the Historical River Channel	0

RISK ASSESSMENT RESULTS			
Flood Risk	<b>Risk: 2</b> <b>Risk Potential Score: 1</b> <b>Risk Severity Score: 1</b>	Minimal assets and infrastructure within and adjacent to the floodplain; however, the south bridge approach to the SH 71E bridge appears to overtop at the 50-year event.	
Fluvial Geomorphic Risk	<b>Risk: 2</b> <b>Risk Potential Score: 1</b> <b>Risk Severity Score: 1</b>	Straight, low-sinuosity channel with low/medium stream power. Minimal lateral migration and erosion potential with no significant channel meander bends. Channel is bordered by floodplain and riparian corridor with minimal assets except at the outer edges of the erosional hazard area.	
Ecological Risk	<b>Potential for Restoration: 5</b> <b>Risk Score: 2</b> <b>Restoration Priority Score: 3</b>	<b>SVAP2 Average Score: 6.2.</b> There are no artificial barriers that restrict aquatic species movement. Canopy cover over the stream channel is moderate, and there is little algal growth.

Overall Risk Score	<b>9 - Low</b>		
Restoration Recommendations	No specific projects were identified within this reach.

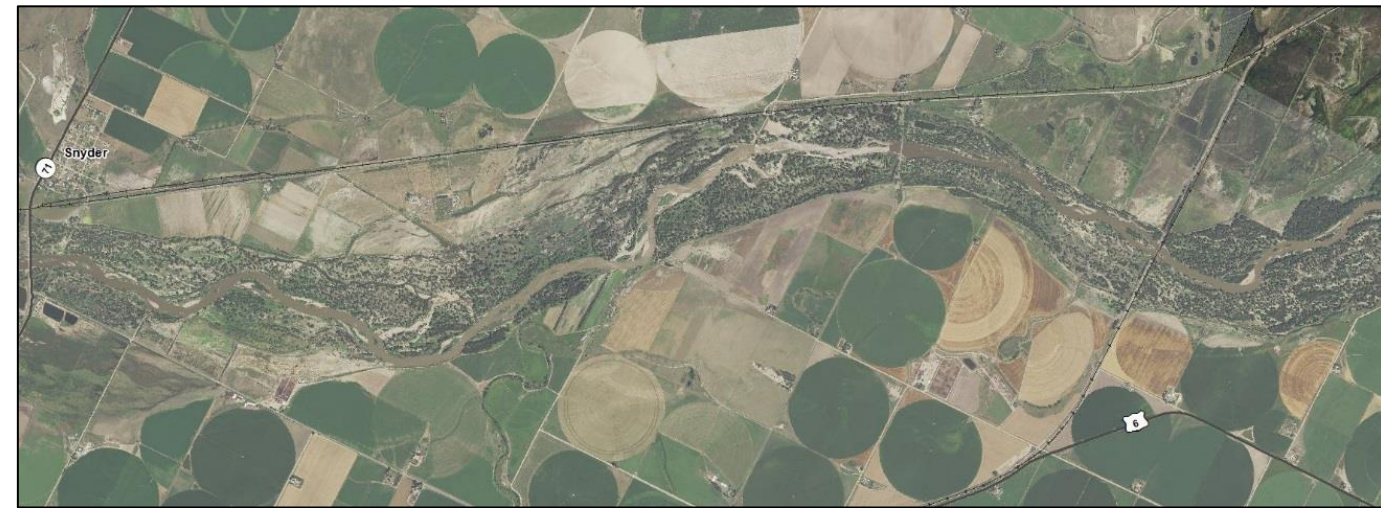
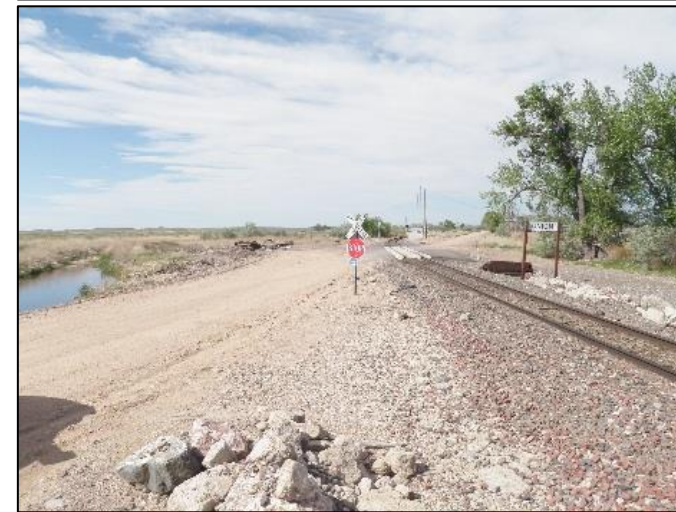
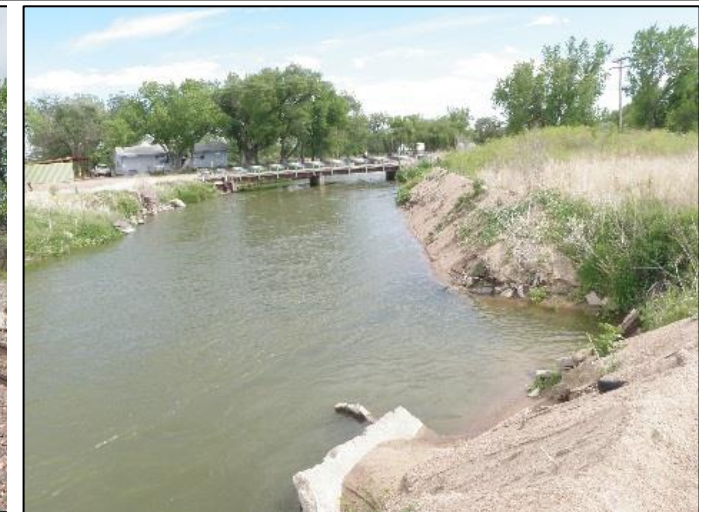
**Table 5-15: Reach 7 Summary**

RIVER CHARACTERISTICS			
Valley Setting	The channel sits in a partially confined valley with a partially connected floodplain and riparian corridor.		
Channel Characteristics	The channel has broad, low-frequency meanders with small-scale, internal, high-frequency, low-amplitude meander bends. The river is a variable single- and multi thread channel, with braiding and sandbars at low/medium flows. The channel has a connected floodplain and riparian corridor, except where meanders are migrating out of the historical river channel and onto agricultural land.		
RIVER STATISTICS			
Average Stream Power 10-year (lbs/ft <sup>2</sup> s)	0.65	Structures in the Active Channel	0
Average Stream Power 100-year (lbs/ft <sup>2</sup> s)	1.10	Structures in the Erosional Hazard Area	7
Number of Diversions Passing Sediment	1	Structures in the Historical River Channel	18
Number of Diversions Not Passing Sediment	0	Potential Erosion Points	1

Critical Infrastructure in the Active Channel	0	NPDES in the Active Channel	0
Critical Infrastructure in the Erosional Hazard Area	0	NPDES in the Erosional Hazard Area	2
Critical Infrastructure in the Historical River Channel	0	NPDES in the Historical River Channel	2
RISK ASSESSMENT RESULTS			
Flood Risk	<b>Risk: 5</b> <b>Risk Potential Score: 2</b> <b>Risk Severity Score: 3</b>	The 2013 flood caused damage to roadway infrastructure in this reach, which had significant impacts downstream. The breach of the railroad trapped substantial amounts of water in the Town of Messex, which had to return flow path to the river.	
Fluvial Geomorphic Risk	<b>Risk: 4</b> <b>Risk Potential Score: 2</b> <b>Risk Severity Score: 2</b>	Sinuous, meandering channel with medium/high stream power. Moderate lateral migration and erosion potential with areas where significant assets are located within the erosional hazard area on the outside of meander bends, as well as regions where the channel is encroaching/eroding into the historical river channel and agricultural land. Conversely, other large portions of the channel are buffered by floodplain and riparian habitat.

Ecological Risk	<b>Potential for Restoration: 5</b> <b>Risk Score: 2</b> <b>Restoration Priority Score: 3</b>	<b>SVAP2 Average Score: 4.7.</b> Invasive species are present in the riparian zone, but there are relatively few gaps in vegetation. Canopy cover over the stream channel is moderate. There are physical barriers within the channel that restrict the movement of aquatic species, and there few aquatic habitat types.	
Overall Risk Score	<b>14 - High</b>		
Restoration Recommendations	Recommended projects within this reach include raising the Morgan County Road 33 bridge approaches, sediment removal, implementing a two-stage channel design, and implementing additional culvert crossings along the railroad bridge (see Section 7.2.2).

- **Reach 7:** Significant damage to the roadway infrastructure along this reach occurred as a result of the 2013 flood, including damage to the Morgan County Road 33 bridge and approaches, the Burlington Northern Santa Fe (BNSF) Railroad, and Morgan County Road W7. The breach of the railroad west of the floodplain contributed to downstream flooding into the Town of Messex, as described under Reach 8. Assets adjacent to the floodplain are within the mapped EHA, resulting in elevated geomorphic risk. The North Sterling

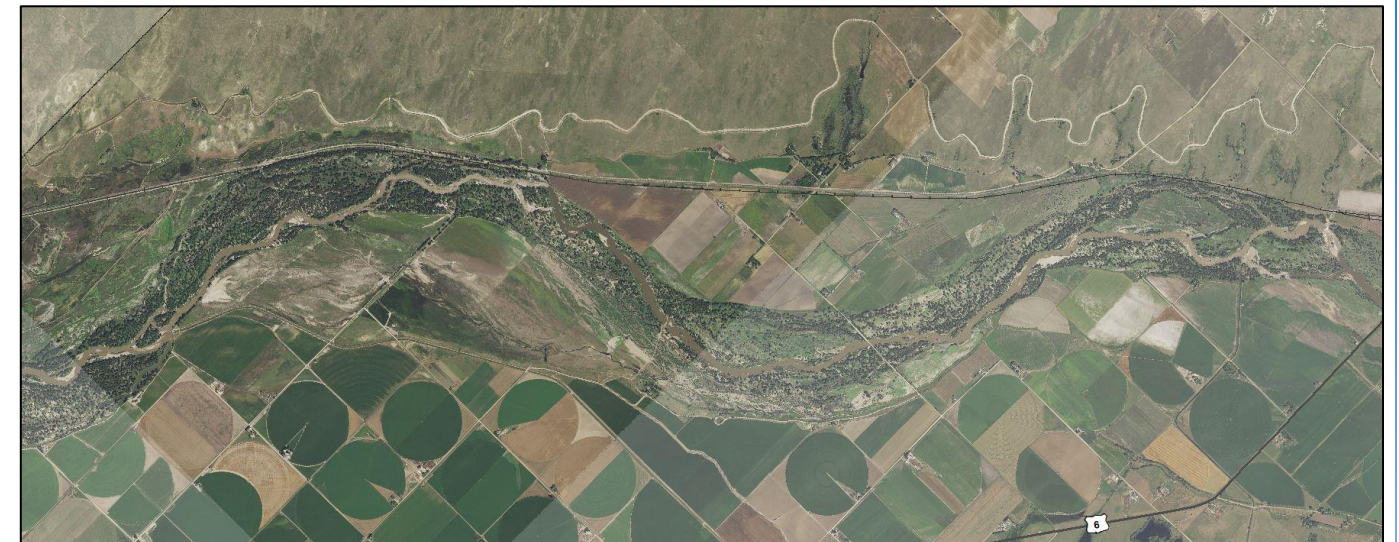
**Table 5-16: Reach 8 Summary**

RIVER CHARACTERISTICS			
Valley Setting	The channel sits in a partially confined valley with a partially connected floodplain and riparian corridor.		
Channel Characteristics	The channel has broad, low-frequency meanders with internal, high-frequency, low-amplitude bends. It is a variable single- and multi-thread channel, with braiding and sandbars at low/medium flows. The floodplain and riparian corridor are connected, except where meanders are migrating out of the historical river channel and onto agricultural land.		
RIVER STATISTICS			
Average Stream Power 10-year (lbs/ft <sup>2</sup> s)	0.43	Structures in the Active Channel	0
Average Stream Power 100-year (lbs/ft <sup>2</sup> s)	0.92	Structures in the Erosional Hazard Area	5
Number of Diversions Passing Sediment	1	Structures in the Historical River Channel	12
Number of Diversions Not Passing Sediment	3	Potential Erosion Points	3
Critical Infrastructure in the Active Channel	0	NPDES in the Active Channel	0

Critical Infrastructure in the Erosional Hazard Area	0	NPDES in the Erosional Hazard Area	0
Critical Infrastructure in the Historical River Channel	0	NPDES in the Historical River Channel	0
RISK ASSESSMENT RESULTS			
Flood Risk	<b>Risk: 4</b> <b>Risk Potential Score: 1</b> <b>Risk Severity Score: 3</b>	This reach includes the Town of Messex, which is outside of the 100-year floodplain, but suffered severe flooding in 2013 due to overtopping of the railroad and of Tetsel Ditch.	
Fluvial Geomorphic Risk	<b>Risk: 3</b> <b>Risk Potential Score: 2</b> <b>Risk Severity Score: 1</b>	Sinuous, meandering channel with low stream power. Lateral migration and erosion potential on outside of meander bends where the channel is encroaching/eroding into the historical river corridor and agricultural land. Inside bends and transition/straight sections of the channel are buffered by floodplains, point bars, and riparian habitat. Assets dominantly located on the inside of meander bends outside, or on the edge, of the erosional hazard area.

Ecological Risk	<b>Potential for Restoration: 5</b> <b>Risk Score: 2</b> <b>Restoration Priority Score: 3</b>	<b>SVAP2 Average Score: 5.4.</b> Physical structures within the channel restrict the movement of aquatic species. Canopy cover over the stream channel is moderate, but invasive species are present in the riparian zone, and there are excessive gaps in vegetation.	
Overall Risk Score	<b>12 - Medium</b>		
Restoration Recommendations	Mitigate standing water in Messex by installing a flow direction berm, installing a flood-control gate for the Tetsel Ditch, and constructing drainage improvements (see Section 7.2.3).

- **Reach 8:** This reach encompasses the northwest corner of Washington County, including Messex. Although Messex is located outside of the updated FEMA 100-year floodplain, the town experienced significant flood impacts during the 2013 and 2015 flood events. These flood impacts were caused by issues in the adjacent upstream reach (Reach 7), which was designated as having a High risk, due to the flooding in Messex, while Reach 8 was given a risk designation of Medium. Portions of Morgan County Road W7, and the railroad tracks near the Washington County line, were overtopped in 2013, leading to conveyance of flood waters through low-lying terrain toward Messex. The railroad embankment trapped flood water on the north side of the railroad embankment. Additionally, the Tetsel Ditch overtopped its banks upstream of Messex, further contributing to the flood issues.

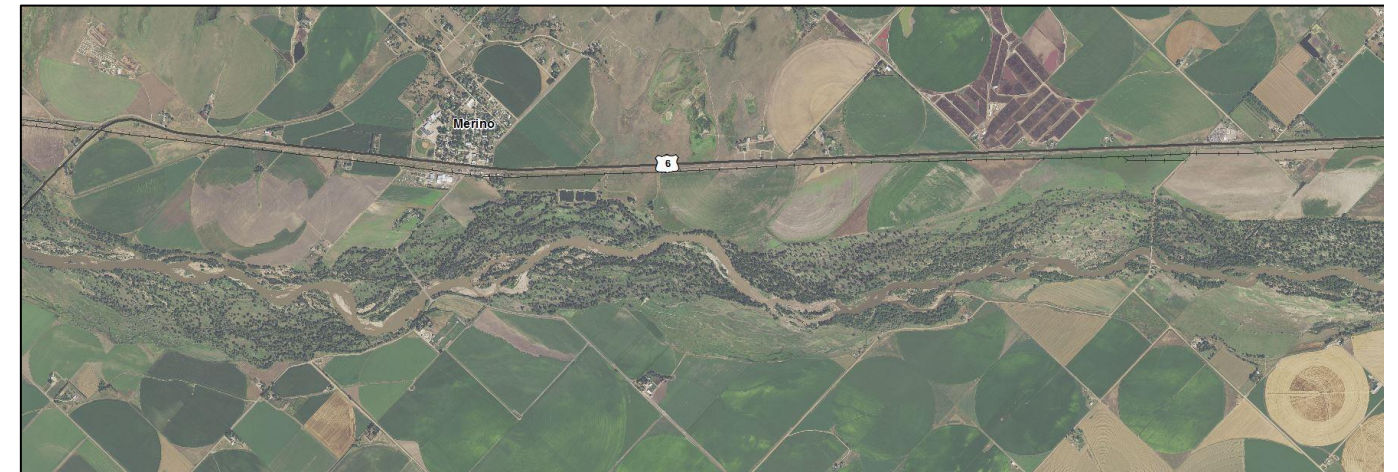
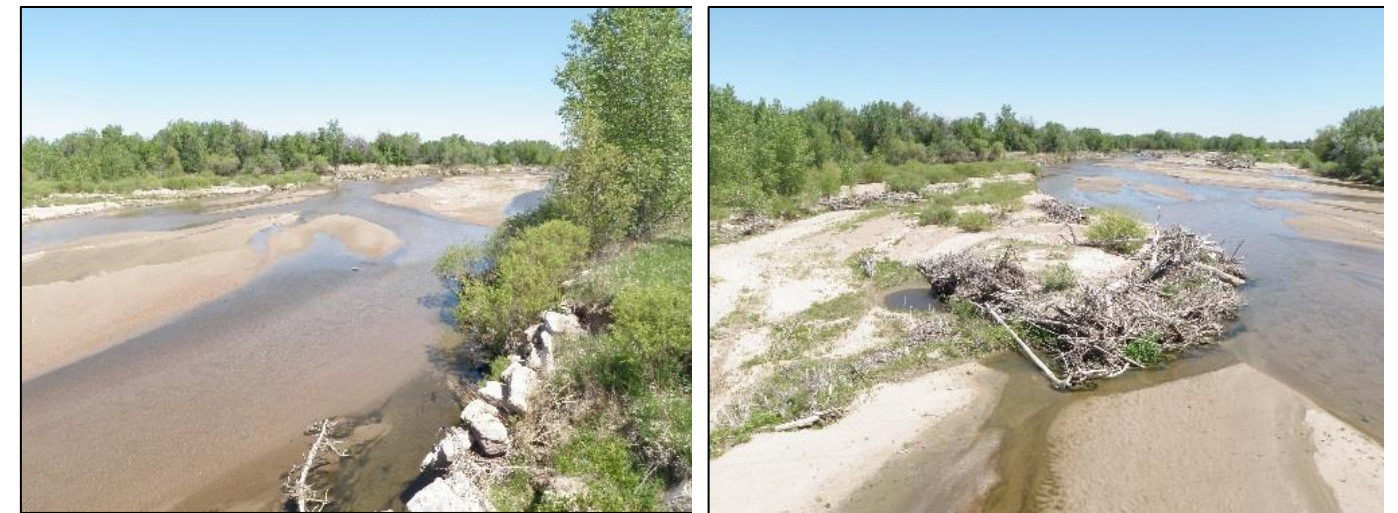
**Table 5-17: Reach 9 Summary**

RIVER CHARACTERISTICS			
Valley Setting	The channel sits in a partially confined valley with a partially connected floodplain and riparian corridor.		
Channel Characteristics	The channel is a relatively straight, low-sinuosity reach with low-amplitude meander bends. It is a variable single- and multi-thread channel, with braiding and sandbars at low/medium flows. The floodplain and riparian corridor are partially connected, except where meanders are migrating out of the historical river corridor and onto agricultural land.		
RIVER STATISTICS			
Average Stream Power 10-year (lbs/ft <sup>2</sup> s)	0.41	Structures in the Active Channel	0
Average Stream Power 100-year (lbs/ft <sup>2</sup> s)	0.95	Structures in the Erosional Hazard Area	1
Number of Diversions Passing Sediment	0	Structures in the Historical River Channel	2
Number of Diversions Not Passing Sediment	1	Potential Erosion Points	1
Critical Infrastructure in the Active Channel	0	NPDES in the Active Channel	0

Critical Infrastructure in the Erosional Hazard Area	0	NPDES in the Erosional Hazard Area	0
Critical Infrastructure in the Historical River Channel	0	NPDES in the Historical River Channel	0
RISK ASSESSMENT RESULTS			
Flood Risk	<b>Risk: 4</b> <b>Risk Potential Score: 1</b> <b>Risk Severity Score: 3</b>	Two bridge approaches within this reach overtop at the 10-year event.	
Fluvial Geomorphic Risk	<b>Risk: 2</b> <b>Risk Potential Score: 1</b> <b>Risk Severity Score: 1</b>	Low-sinuosity channel with low stream power. Minimal lateral migration and erosion potential on outside of low-amplitude meander bends and where the channel is encroaching/eroding into the historical river corridor and agricultural land. Assets dominantly located outside, or on the edge, of the erosional hazard area.	
Ecological Risk	<b>Potential for Restoration: 4</b> <b>Risk Score: 2</b> <b>Restoration Priority Score: 2</b>	<b>SVAP2 Average Score: 4.6.</b> Physical structures within the channel restrict aquatic movement. There is very little canopy cover over the stream channel and there are excessive gaps in riparian vegetation.

Overall Risk Score	<b>10 - Low</b>		
Restoration Recommendations	No specific projects were identified within this reach.

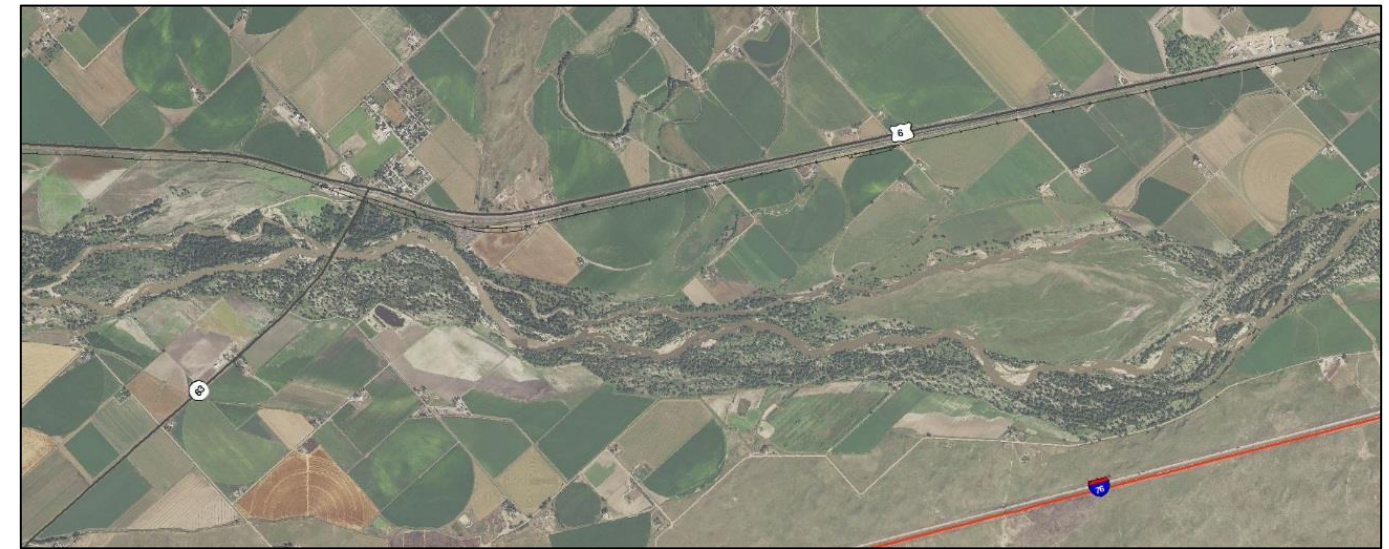
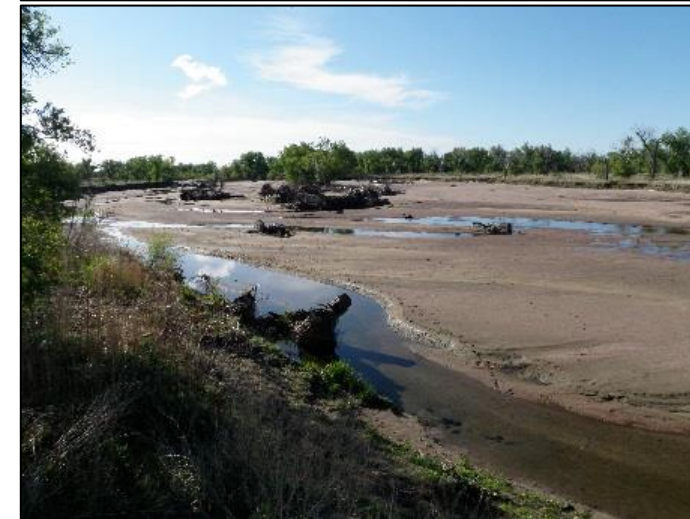
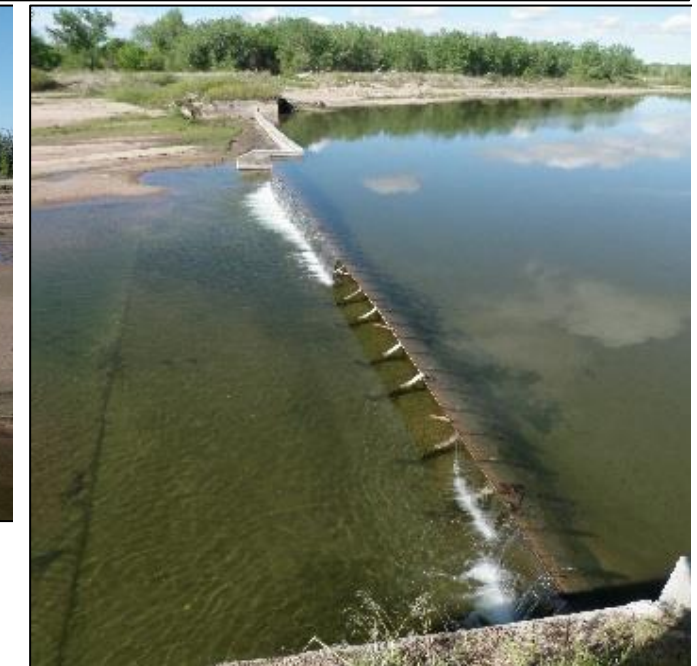
**Table 5-18: Reach 10 Summary**

RIVER CHARACTERISTICS			
Valley Setting	The channel sits in a partially confined valley with a partially connected floodplain and riparian corridor, bound by agricultural land.		
Channel Characteristics	The river is a straight, low-sinuosity reach with a broad active channel zone with multi-thread channels and islands. There is braiding and sandbar formation at low/medium flows. The floodplain and riparian corridor are partially confined by agricultural land encroached by the channel.		
RIVER STATISTICS			
Average Stream Power 10-year (lbs/ft <sup>2</sup> s)	0.52	Structures in the Active Channel	0
Average Stream Power 100-year (lbs/ft <sup>2</sup> s)	1.01	Structures in the Erosional Hazard Area	9
Number of Diversions Passing Sediment	1	Structures in the Historical River Channel	14
Number of Diversions Not Passing Sediment	1	Potential Erosion Points	1
Critical Infrastructure in the Active Channel	0	NPDES in the Active Channel	0

Critical Infrastructure in the Erosional Hazard Area	0	NPDES in the Erosional Hazard Area	0
Critical Infrastructure in the Historical River Channel	0	NPDES in the Historical River Channel	0
RISK ASSESSMENT RESULTS			
Flood Risk	<b>Risk: 2</b> <b>Risk Potential Score: 1</b> <b>Risk Severity Score: 1</b>	Minimal assets and infrastructure within the 100-year floodplain.	
Fluvial Geomorphic Risk	<b>Risk: 5</b> <b>Risk Potential Score: 2</b> <b>Risk Severity Score: 3</b>	Low-sinuosity, multi-thread channel with medium stream power. Lateral migration and erosion potential on outside of low-amplitude meander bends and where the channel is encroaching/eroding agricultural land. Increasing density of assets within the erosional hazard area moving downstream towards Sterling.	
Ecological Risk	<b>Potential for Restoration: 4</b> <b>Risk Score: 2</b> <b>Restoration Priority Score: 2</b>	<b>SVAP2 Average Score: 4.9.</b> Canopy cover over the stream channel is moderate, but there are excessive gaps in riparian vegetation. Physical structures are present in the channel that restrict aquatic movement, and there are few aquatic habitat types.

Overall Risk Score	<b>11 - Medium</b>		
Restoration Recommendations	No specific projects were identified within this reach.

- **Reach 10:** Flood risk is low for this reach, with minimal assets and infrastructure within the Draft CHAMP 100-year FEMA floodplain. High potential for lateral migration and erosion hazards elevate the geomorphic risk, particularly at the in-line channel structures that exist within this reach: the Logan County Road 33.5 bridge crossing, Springdale Diversion, and Sterling No. 1 Diversion.

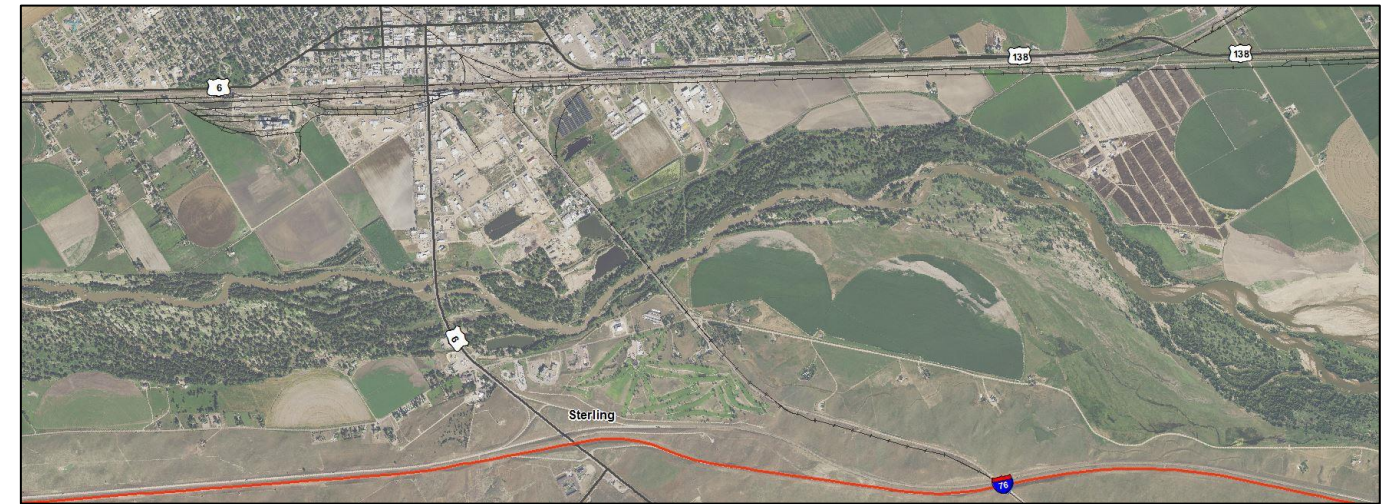
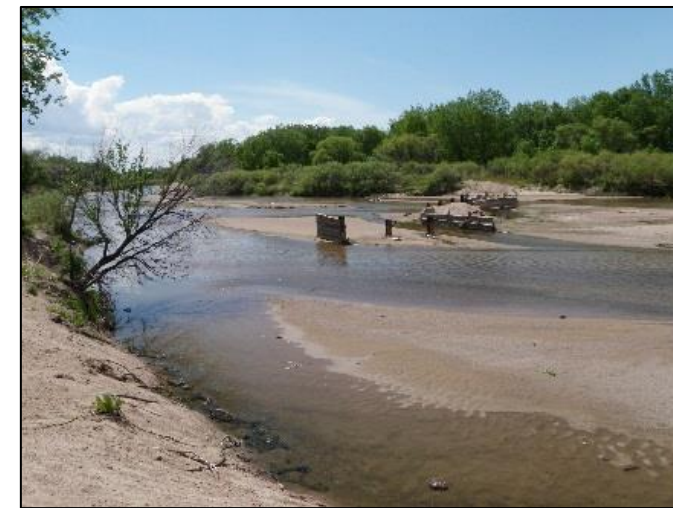
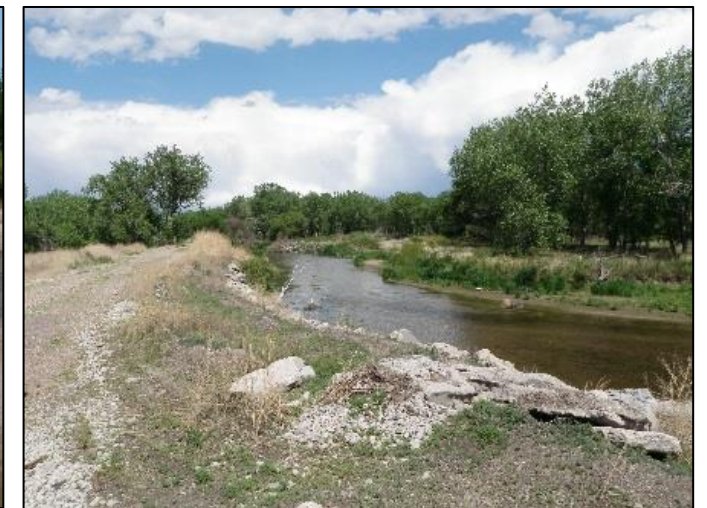
**Table 5-19: Reach 11 Summary**

RIVER CHARACTERISTICS			
Valley Setting	The channel sits in a valley confined by urban channelization and agriculture, with minimal floodplain and riparian corridor.		
Channel Characteristics	The channel is narrow and linear and has been channelized by urban and agricultural development. It is primarily an urban-controlled, single-thread channel with some multi-threads at low/medium flows. The minimal floodplain and riparian corridor is confined by urban and agricultural land.		
RIVER STATISTICS			
Average Stream Power 10-year (lbs/ft <sup>2</sup> s)	0.51	Structures in the Active Channel	0
Average Stream Power 100-year (lbs/ft <sup>2</sup> s)	1.10	Structures in the Erosional Hazard Area	40
Number of Diversions Passing Sediment	0	Structures in the Historical River Channel	234
Number of Diversions Not Passing Sediment	2	Potential Erosion Points	1
Critical Infrastructure in the Active Channel	0	NPDES in the Active Channel	0

Critical Infrastructure in the Erosional Hazard Area	0	NPDES in the Erosional Hazard Area	12
Critical Infrastructure in the Historical River Channel	1	NPDES in the Historical River Channel	12
RISK ASSESSMENT RESULTS			
Flood Risk	<b>Risk: 6</b> <b>Risk Potential Score: 3</b> <b>Risk Severity Score: 3</b>	This reach includes a complicated presence of water diversion infrastructure, SWAs, road and bridge infrastructure, residential properties, and high-risk municipal and commercial infrastructure, all within the floodplain, and in a condensed reach of the river.	
Fluvial Geomorphic Risk	<b>Risk: 6</b> <b>Risk Potential Score: 3</b> <b>Risk Severity Score: 3</b>	Narrow, low-sinuosity channel with medium/high stream power and significant development driven channelization. High lateral migration and erosion potential with the channel encroaching/eroding on urban and/or agricultural land along the entire reach. Significant assets within the erosional hazard area, with the highest density centered on Sterling.

Ecological Risk	<b>Potential for Restoration: 5</b> <b>Risk Score: 2</b> <b>Restoration Priority Score: 3</b>	<b>SVAP2 Average Score: 4.7.</b> There are physical structures in the channel that restrict aquatic movement. There are large gaps in riparian vegetation and invasive species are present in the riparian zone. The water is slightly turbid and livestock seem to have unlimited access to the stream during parts of the year.	
Overall Risk Score	<b>17 - High</b>		
Restoration Recommendations	Flood-proof critical infrastructure, manage the river corridor through non-structural means, including sediment removal and land management, and establish a stream restoration plan (see Section 7.2.4).

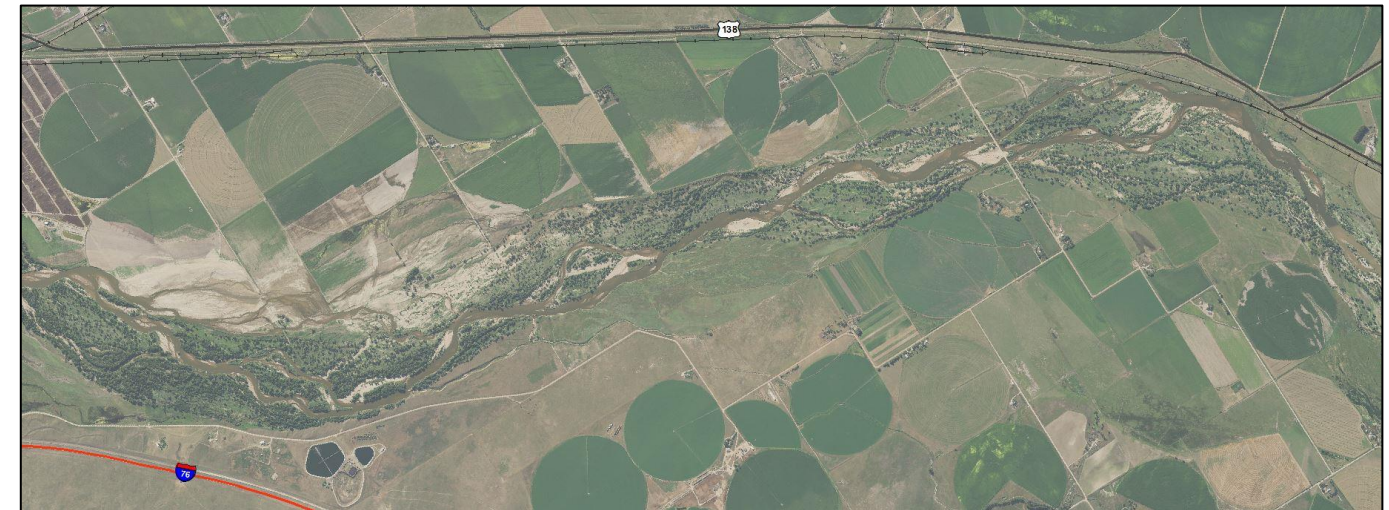
**Table 5-20: Reach 12 Summary**

RIVER CHARACTERISTICS			
Valley Setting	The channel sits in a partially confined valley with a narrow, partially connected floodplain and riparian corridor.		
Channel Characteristics	The river is a linear, multi-thread channel with a narrow floodplain and riparian corridor, confined by agricultural land.		
RIVER STATISTICS			
Average Stream Power 10-year (lbs/ft <sup>2</sup> s)	0.43	Structures in the Active Channel	0
Average Stream Power 100-year (lbs/ft <sup>2</sup> s)	0.83	Structures in the Erosional Hazard Area	3
Number of Diversions Passing Sediment	0	Structures in the Historical River Channel	6
Number of Diversions Not Passing Sediment	2	Potential Erosion Points	1
Critical Infrastructure in the Active Channel	0	NPDES in the Active Channel	0
Critical Infrastructure in the Erosional Hazard Area	0	NPDES in the Erosional Hazard Area	0
Critical Infrastructure in the Historical River Channel	0	NPDES in the Historical River Channel	0

RISK ASSESSMENT RESULTS			
Flood Risk	<b>Risk: 2</b> <b>Risk Potential Score: 1</b> <b>Risk Severity Score: 1</b>	Several small county roads are within the 100-year floodplain.	
Fluvial Geomorphic Risk	<b>Risk: 2</b> <b>Risk Potential Score: 1</b> <b>Risk Severity Score: 1</b>	Near-linear, low-sinuosity channel with low stream power. Moderate lateral migration and erosion potential with channel encroaching/eroding on bounding agricultural land. Minimal assets within the erosional hazard area.	
Ecological Risk	<b>Potential for Restoration: 5</b> <b>Risk Score: 2</b> <b>Restoration Priority Score: 3</b>	<b>SVAP2 Average Score: 5.5.</b> Canopy cover over the stream channel is moderate, and there is little algal growth. Physical structures are present that restrict aquatic movement and there are few aquatic habitat types present.	
Overall Risk Score	<b>9 - Low</b>		
Restoration Recommendations	No specific projects were identified within this reach.
