# Lower South Platte River Master Plan

## Morgan County

## CDM Smith

April 9, 2018

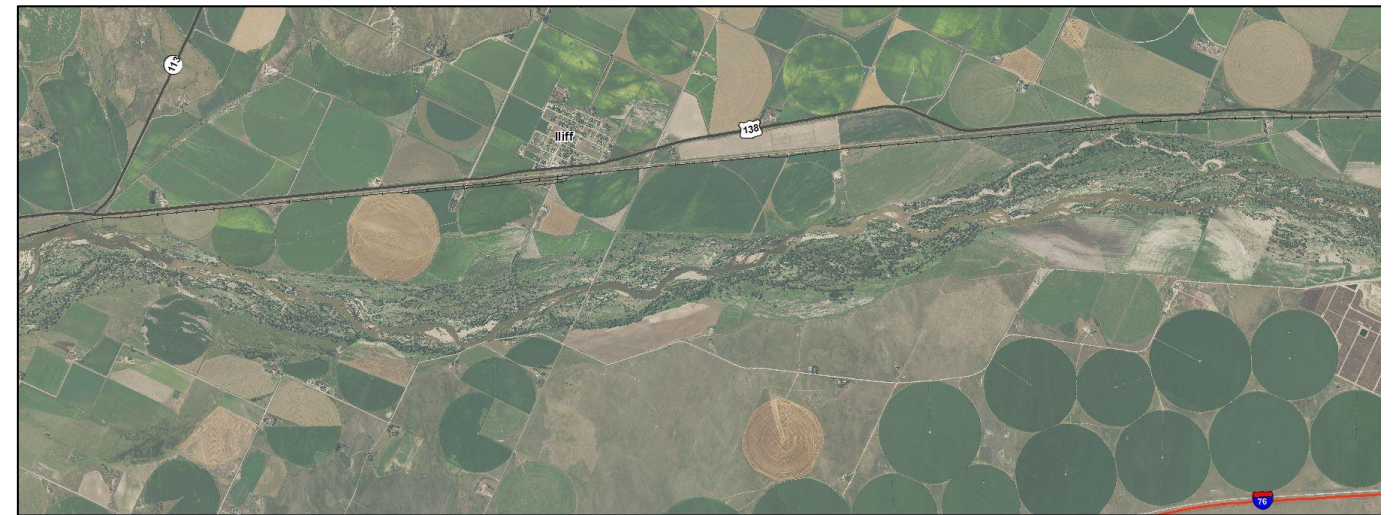
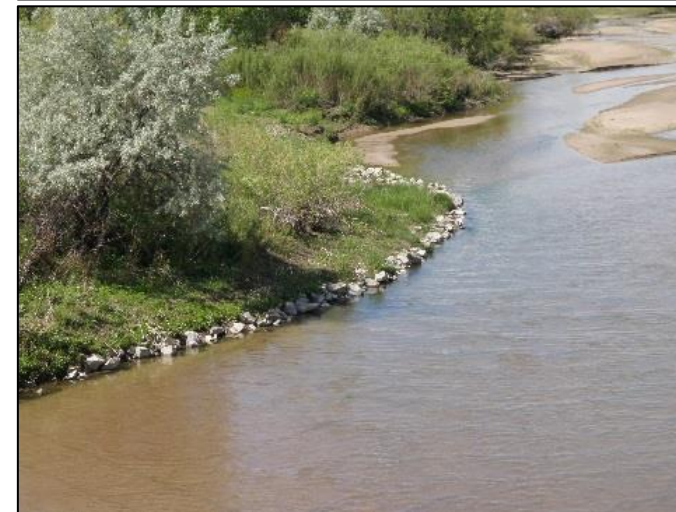
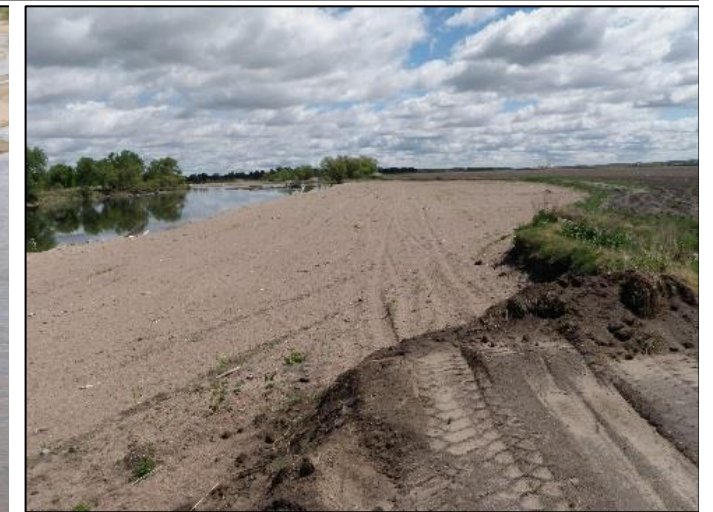
**Table 5-21: Reach 13 Summary**

RIVER CHARACTERISTICS			
Valley Setting	The channel sits in a partially confined valley with a partially connected floodplain and riparian corridor.		
Channel Characteristics	The river is a near-linear, multi-thread channel along a broad left-hand bend, with braiding and sandbar development at low/medium flows. The floodplain and riparian corridor is confined by agricultural land.		
RIVER STATISTICS			
Average Stream Power 10-year (lbs/ft <sup>2</sup> s)	0.37	Structures in the Active Channel	1
Average Stream Power 100-year (lbs/ft <sup>2</sup> s)	0.85	Structures in the Erosional Hazard Area	3
Number of Diversions Passing Sediment	0	Structures in the Historical River Channel	267
Number of Diversions Not Passing Sediment	2	Potential Erosion Points	2
Critical Infrastructure in the Active Channel	0	NPDES in the Active Channel	0
Critical Infrastructure in the Erosional Hazard Area	0	NPDES in the Erosional Hazard Area	0

Critical Infrastructure in the Historical River Channel	0	NPDES in the Historical River Channel	1
RISK ASSESSMENT RESULTS			
Flood Risk	<b>Risk: 5</b> <b>Risk Potential Score: 3</b> <b>Risk Severity Score: 2</b>	The majority of the Town of Iliff is located within the 100-year floodplain, and the north approach to the Logan County Road 55 bridge appears to overtop at the 10-year flood event.	
Fluvial Geomorphic Risk	<b>Risk: 2</b> <b>Risk Potential Score: 1</b> <b>Risk Severity Score: 1</b>	Near-linear, low-sinuosity channel with low stream power. Moderate lateral migration and erosion potential with channel encroaching/eroding into bounding agricultural land. Minimal assets within the erosional hazard area, and the town of Iliff is on the inside of the bend and outside of the erosional hazard area.	
Ecological Risk	<b>Potential for Restoration: 4</b> <b>Risk Score: 2</b> <b>Restoration Priority Score: 2</b>	<b>SVAP2 Average Score: 5.0</b> The water is slightly turbid and there are physical structures present that restrict aquatic movement. There is very little canopy cover and there are excessive gaps in riparian vegetation.

Overall Risk Score	<b>11 - Medium</b>		
Restoration Recommendations	No specific projects were identified within this reach.

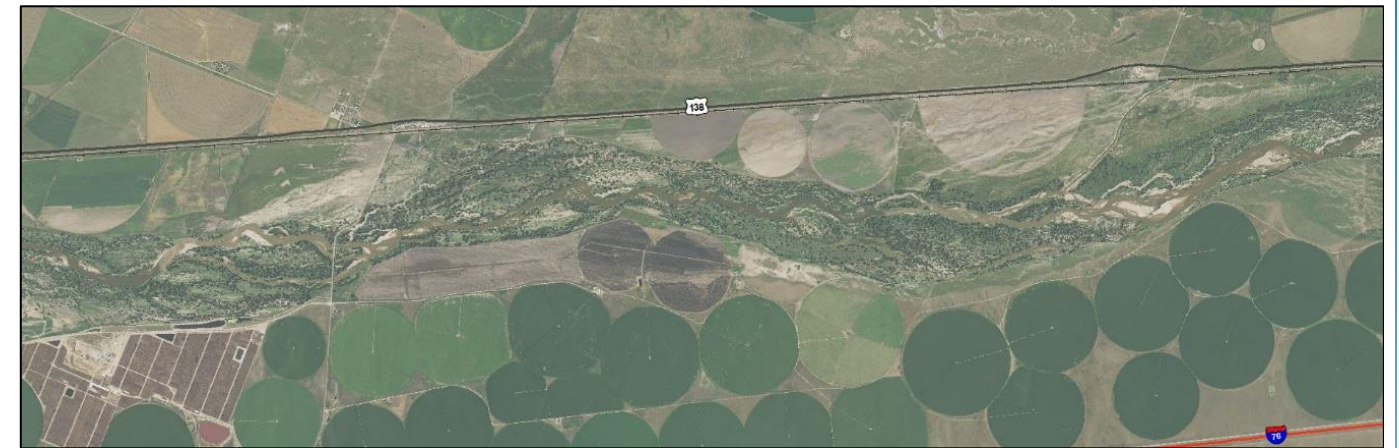
**Table 5-22: Reach 14 Summary**

RIVER CHARACTERISTICS			
Valley Setting	The channel sits in a partially confined valley with a partially connected floodplain and riparian corridor.		
Channel Characteristics	The channel is linear and multi-thread, with braiding and sandbar development at low/medium flows. The floodplain and riparian corridor are confined by agricultural land.		
RIVER STATISTICS			
Average Stream Power 10-year (lbs/ft <sup>2</sup> s)	0.86	Structures in the Active Channel	0
Average Stream Power 100-year (lbs/ft <sup>2</sup> s)	0.85	Structures in the Erosional Hazard Area	2
Number of Diversions Passing Sediment	1	Structures in the Historical River Channel	37
Number of Diversions Not Passing Sediment	3	Potential Erosion Points	1
Critical Infrastructure in the Active Channel	0	NPDES in the Active Channel	0
Critical Infrastructure in the Erosional Hazard Area	0	NPDES in the Erosional Hazard Area	0
Critical Infrastructure in the Historical River Channel	0	NPDES in the Historical River Channel	0

RISK ASSESSMENT RESULTS			
Flood Risk	<b>Risk: 2</b> <b>Risk Potential Score: 1</b> <b>Risk Severity Score: 1</b>	Roadway infrastructure and agricultural land are the main assets at risk of flooding.	
Fluvial Geomorphic Risk	<b>Risk: 3</b> <b>Risk Potential Score: 2</b> <b>Risk Severity Score: 1</b>	Linear, low-sinuosity channel with medium stream power. Moderate lateral migration and erosion potential with channel encroaching/eroding into bounding agricultural land. Minimal assets within the erosional hazard area.	
Ecological Risk	<b>Potential for Restoration: 5</b> <b>Risk Score: 2</b> <b>Restoration Priority Score: 3</b>	<b>SVAP2 Average Score: 4.5.</b> Physical structures are present that restrict the movement of aquatic species. Canopy cover is moderate, and invasive species are present in the riparian zone.	
Overall Risk Score	<b>10 - Low</b>		
Restoration Recommendations	No specific projects were identified within this reach.

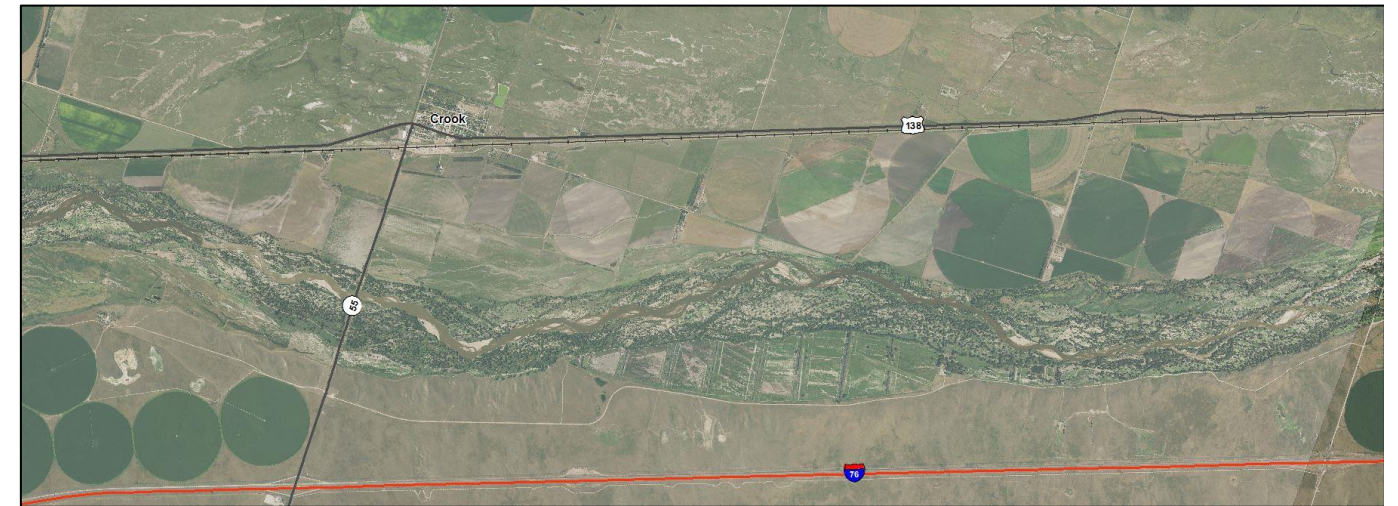
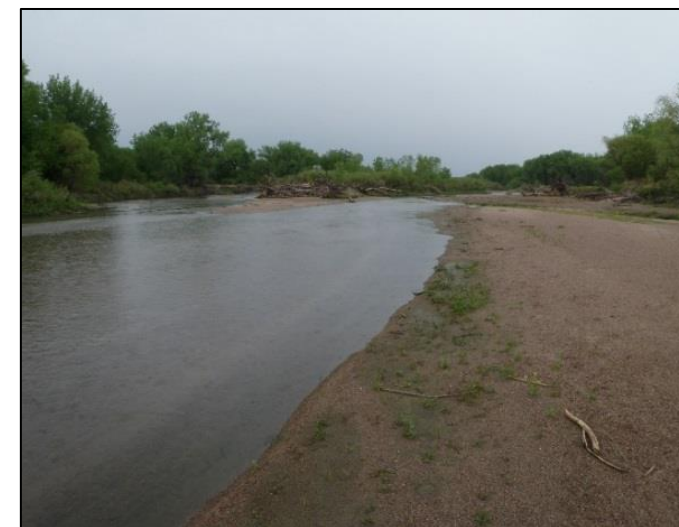
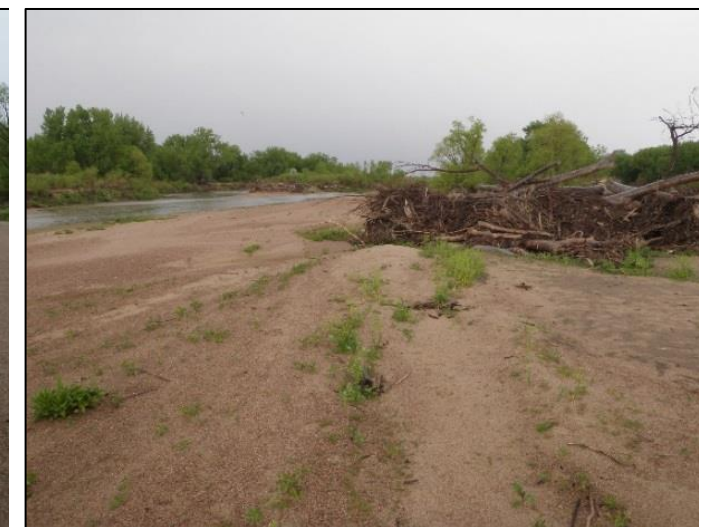
**Table 5-23: Reach 15 Summary**

RIVER CHARACTERISTICS			
Valley Setting	The channel sits in a partially confined valley with a partially connected floodplain and riparian corridor.		
Channel Characteristics	The channel is broad with large amplitude meander bends. The channel is single thread, but multi-thread channels develop at low flows. The channel corridor is primarily bordered by riparian zone and a partially connected floodplain.		
RIVER STATISTICS			
Average Stream Power 10-year (lbs/ft <sup>2</sup> s)	0.33	Structures in the Active Channel	0
Average Stream Power 100-year (lbs/ft <sup>2</sup> s)	0.70	Structures in the Erosional Hazard Area	0
Number of Diversions Passing Sediment	0	Structures in the Historical River Channel	132
Number of Diversions Not Passing Sediment	3	Potential Erosion Points	0
Critical Infrastructure in the Active Channel	0	NPDES in the Active Channel	0
Critical Infrastructure in the Erosional Hazard Area	0	NPDES in the Erosional Hazard Area	0

Critical Infrastructure in the Historical River Channel	0	NPDES in the Historical River Channel	1
RISK ASSESSMENT RESULTS			
Flood Risk	<b>Risk: 5</b> <b>Risk Potential Score: 3</b> <b>Risk Severity Score: 2</b>	The Town of Crook sits within the 100-year floodplain, and likely experiences flooding at the 25-year event.	
Fluvial Geomorphic Risk	<b>Risk: 2</b> <b>Risk Potential Score: 1</b> <b>Risk Severity Score: 1</b>	Low-sinuosity, meandering channel with low stream power. Moderate lateral migration and erosion potential with channel encroaching/eroding into bounding agricultural land. Minimal assets within the erosional hazard area.	
Ecological Risk	<b>Potential for Restoration: 5</b> <b>Risk Score: 2</b> <b>Restoration Priority Score: 3</b>	<b>SVAP2 Average Score: 5.3.</b> Canopy cover over the stream channel is moderate and there are few vegetation gaps in the riparian zone. Physical structures are present that restrict the movement of aquatic species.

Overall Risk Score	<b>12 - Medium</b>		
Restoration Recommendations	Install a FEMA-certified levee, perform land management and sediment removal, and construct a high-water bypass for the Colorado State Highway 55 bridge (see Section 7.2.5).
